Office of Operating Experience Analysis, EH-33 • U.S. Department of Energy • Washington, D.C. 20585

OPERATING EXPERIENCE WEEKLY SUMMARY

January 16 - January 22, 1998

Summary 98-03

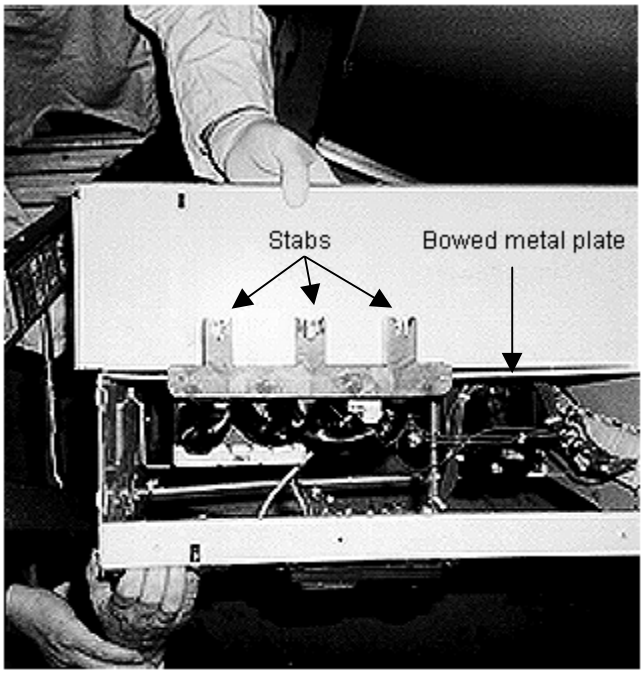
The fan had been shut down since October 1997, because of a turning vane problem. Operators started the exhaust fan in slow speed to run for an hour to warm up the bearings. After the warm-up period, they shifted the fan to fast speed, and the motor control center failed when arcing occurred between a stab (friction connector) and its bus bar.

Figure 2-1. Damaged Circuit Breaker Bucket

After the July failure, facility operations personnel disassembled the unit to determine the source of the trouble. They discovered that the manufacturer had installed the mounting brackets for the bus bars backwards. Operations personnel removed the complete back plane from an identical spare motor control center. They planned to install it in the failed unit to return the motor control center to service. However, upon disassembly of the spare motor control center, they discovered that the brackets in that unit were also installed backwards. Operations personnel installed the spare plane in the motor control center for the exhaust fan and correctly installed the bus-bar mounting brackets.

Facility operations personnel contacted the manufacturer for assistance with troubleshooting and repair of the motor control center. A Westinghouse representative inspected the unit and found that workers at the factory improperly installed the mounting brackets. He also verified that facility operations personnel correctly installed the brackets from the spare. The Westinghouse representative also added stiffeners to the back plane. After operations personnel rebuilt the exhaust fan motor control center, they successfully tested it in accordance with the National Electrical Testing Association procedures and a test inspection plan. Tests included infrared thermograph readings, torque measurements, and megger readings.

Electrical maintenance personnel at DOE facilities that have this type of motor control center should check for (1) flexing of the back plane, (2) proper alignment and engagement of the circuit breaker buckets, and (3) deterioration of the stabs. Technical information can be obtained by contacting Merle Koepke (505) 665-2098 or Mike Kuzmack (505) 665-3281.

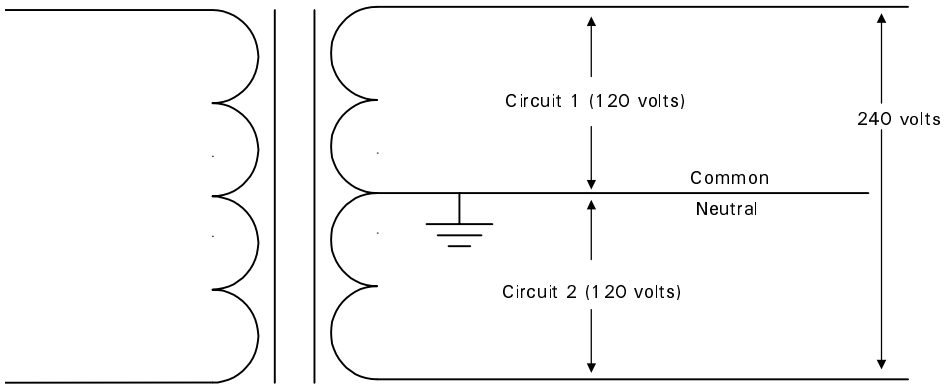
Investigators determined that the two circuits shared a common neutral line, a practice commonly referred to as an "Edison circuit." According to the occurrence report, this configuration is approved by the National Electrical Code, and is widely used, especially in non-industrial service such as 120-volt lighting and receptacles. Figure 2-1 shows the wiring of a typical Edison circuit. The DOE-Idaho Operation Office *Architectural Engineering Standards*, dated November 1994, no longer permit this practice for new construction at the Laboratory.

Figure 2-1. Typical Edison Circuit Wiring[1]

Immediate corrective actions for this occurrence were to restore the configuration of the circuit and to make the required notifications. The operating contractor's electrical safety committee recommended that electricians perform one of the following modifications when an Edison circuit is discovered.

- Install additional neutral wiring to eliminate the Edison circuit.
- Install clips on the affected circuit breakers that will open when either "hot" leg of the Edison circuit is opened.
- Post warning signs on the panels indicating that Edison circuits are installed in the associated electrical systems.
